Don't get MAD

The causes of "Problem glass" and proven solutions - are like elephants in the room

Stephen Byers
RITEC International Ltd

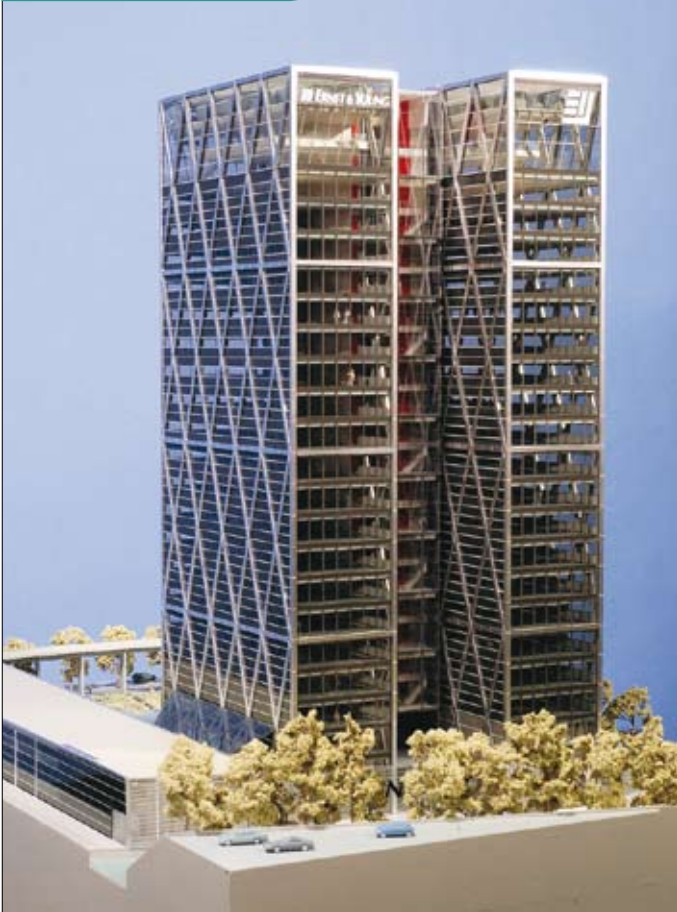
Vivaldi, Netherlands:
New glass, factory application

- Vivaldi Building, Amsterdam – a 23-storey, eco-friendly office building with a zero emission heating and cooling system using geothermal power. Windows with insulated glass (IG) units made of solar control glass laminated with fire resistant (10,000 m²) and coloured glass panels (5,000 m²) were at risk of attack by ‘MAD’ in the form of atmospheric pollution (organic), run-off from brickwork

(inorganic) and seaspray (inorganic). The solution was application before construction of ClearShield® at Ritec’s subsidiary in Holland.

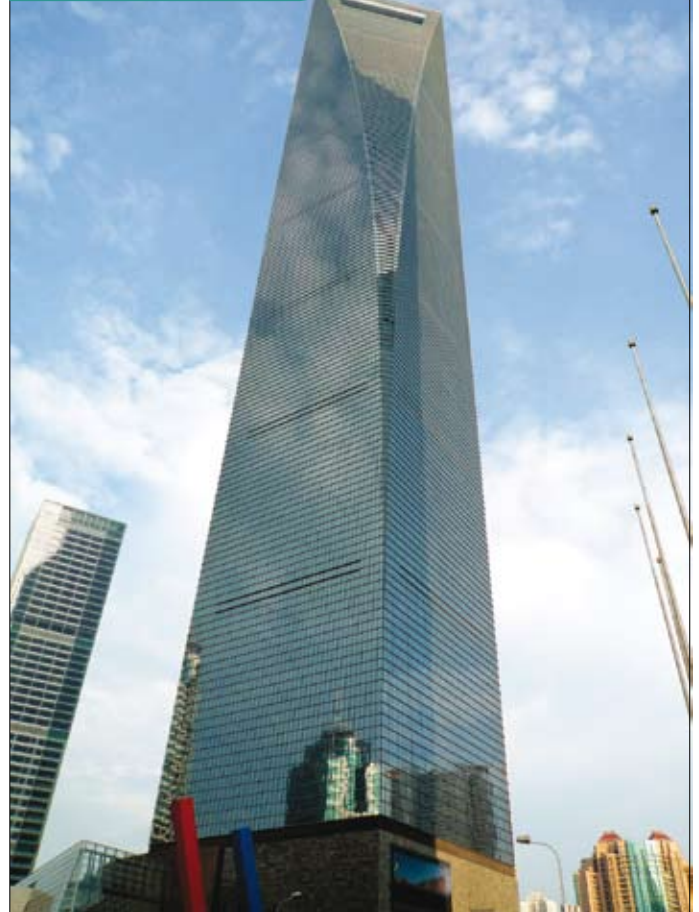
Shanghai World Finance Center:
New glass, factory application

- Shanghai World Financial Center (WFC) – one of the tallest buildings in the world at 101 storeys (492m). All exterior glazing was at risk of attack during construction by ‘MAD’ in the form of cement dust, concrete splatters and run-off (inorganic) and urban pollution (organic). The solution was application before construction of ClearShield® at factories of the glazing fabricator.

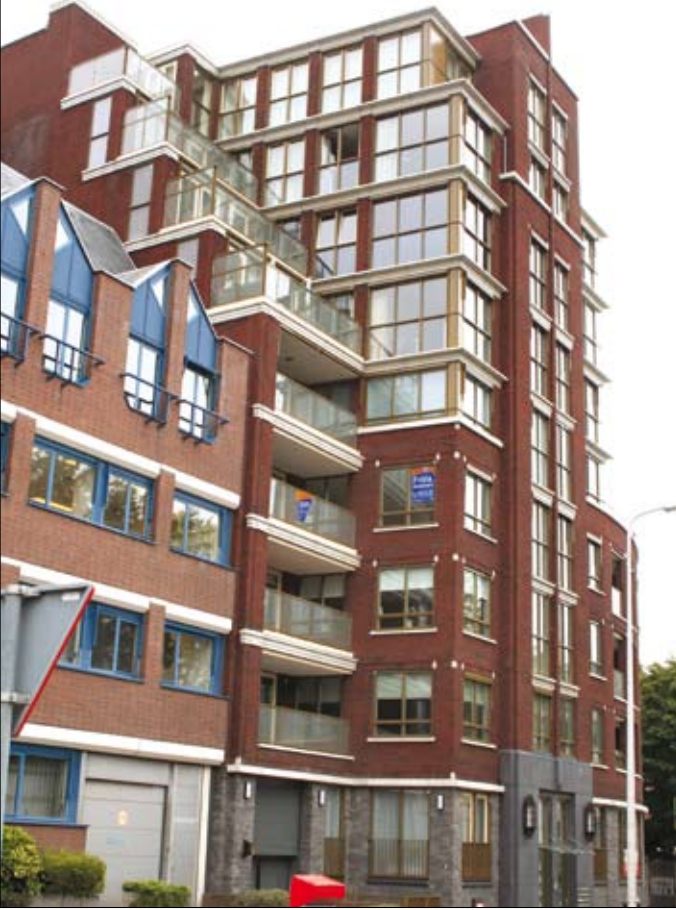
Metropole Building, The Hague:
Existing glass, on-site renovation & protection

- Metropole Building, The Hague – a nine-storey apartment building in the

city centre and only 18 months old when work was carried out for 850 m² of Problem Glass caused by urban pollution (organic), run-off from brickwork (inorganic) and seaspray (inorganic). The solution was Ritec’s surface renovation process and ClearShield® durable, “non-stick” surface protection applied on-site.

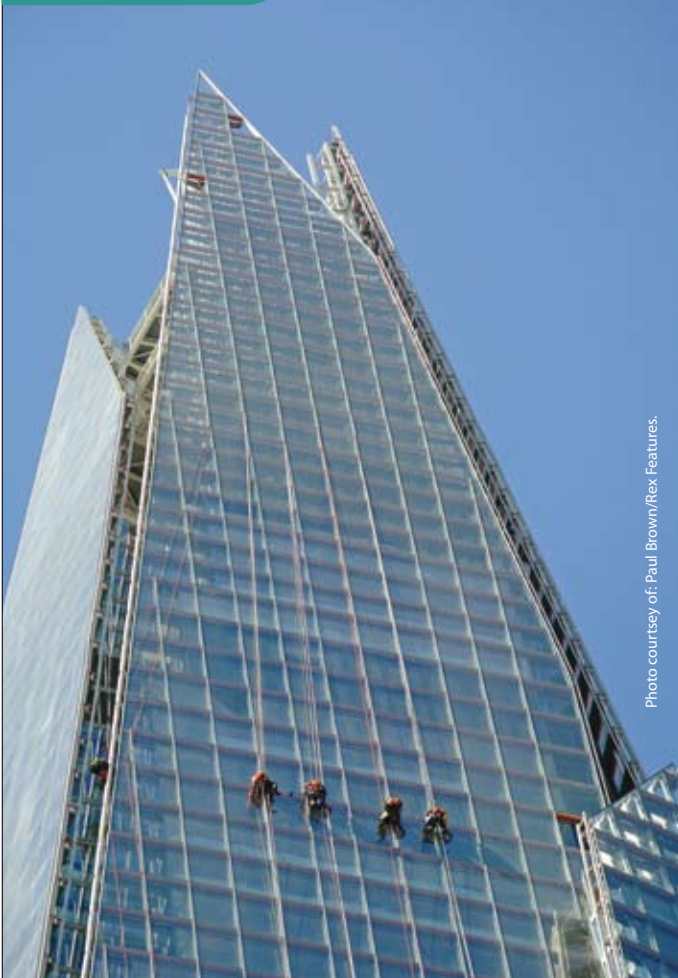
The Shard, London:
On-site renovation only

- The Shard, London – now the tallest building in the UK and one of the tallest in Europe with 95 floors (310 metres or 1,016 ft high). During construction, cement slurry (inorganic) spilled over majority of its exterior glazing and dried on the surface with a risk of etching and

physically damaging the surface. Technical consultants recommended Ritec’s glass renovation process as the safest and most cost-effective solution for removal of the contamination. Application of the renovation process was made by rope access as shown in the photograph.

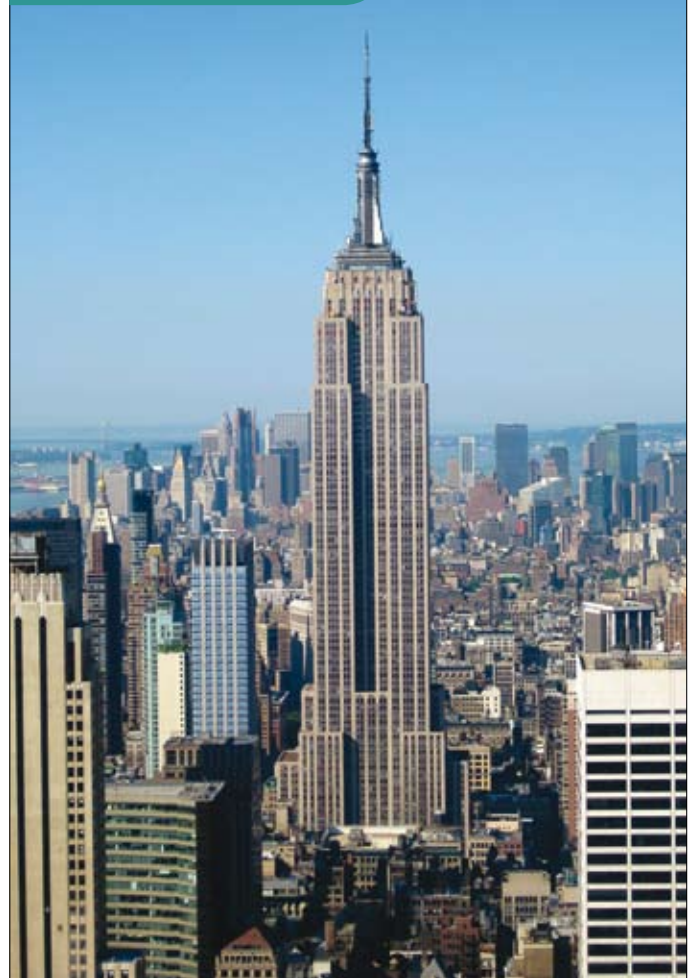
Empire State Building, New York City:
On-site renovation only

- Empire State Building, New York City – completed in 1931, this building is famous worldwide and several years ago embarked on a building renovation programme which included removal of all the original glass and using it to make new insulating glass (IG) units which were re-installed. This required in-depth cleaning of glass with more than 80 years of exposure to urban pollution (organic) and building run-off (inorganic). Ritec’s surface renovation process was selected as the safest and most cost-effective solution and this was applied at a special workshop set up inside the building.
